**The World War II and Early Cold War Architectural Legacy
of Holloman Air Force Base (ca. 1942-1962)**

**by
Martyn D. Tagg**

**Holloman Air Force Base
Cultural Resources Publication No. 6**

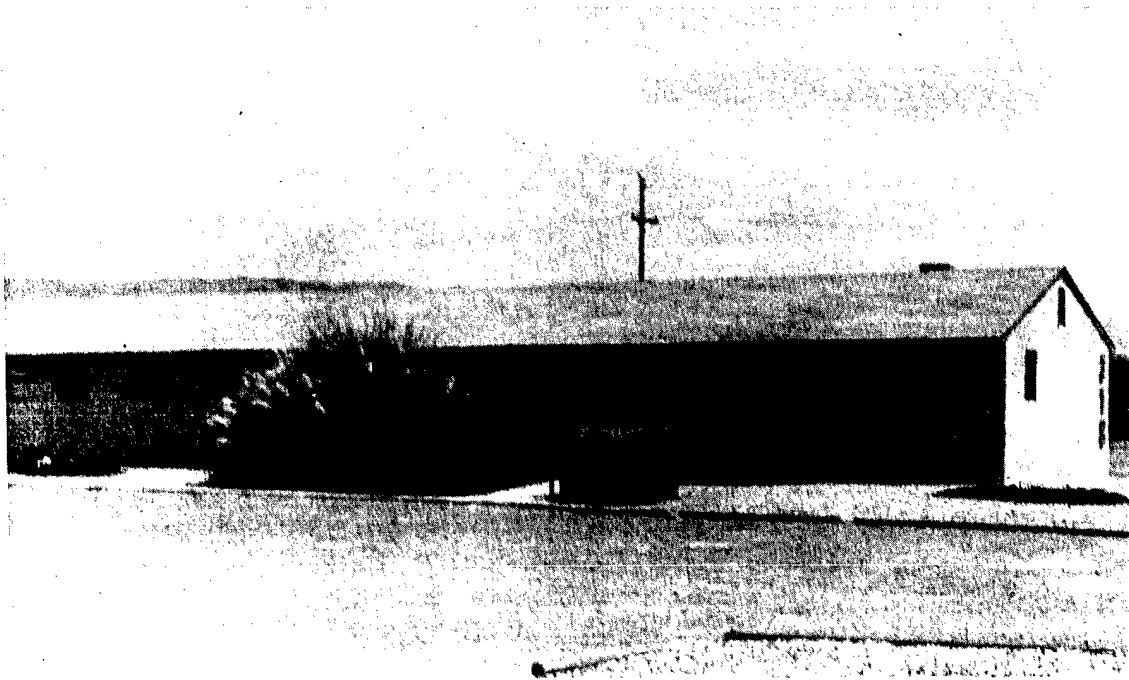
Figure 14. Building 218 as the Thrift Shop in 1996, northwest and southwest elevations.

Building 218, located in the central part of the Main Base, was a temporary facility completed ca. 1943 as an Airmen Dormitory (see Figure 10 and Appendix C). The building is one story with a long, rectangular footprint, an offset at the center of the rear (southeast) elevation, and a low, gable roof (Figure 14). Original construction consisted of asbestos cement shingles on gypsum sheathing and a wood frame. The roof was slate, the floor wood and mastipave, and the foundation concrete piers on isolated footings. The

Building 218 appears to have been one of the 20' x 100' TO-type temporary structures originally constructed to house military personnel in 1943 and is the only remaining WW II housing unit on HAFB. The building retains its original rectangular footprint, single story scope, and gable roof profile, although it no longer retains historic integrity due to extensive architectural modifications. All original doors and windows have been replaced and one window opening has been framed in. At the northwest (principal)

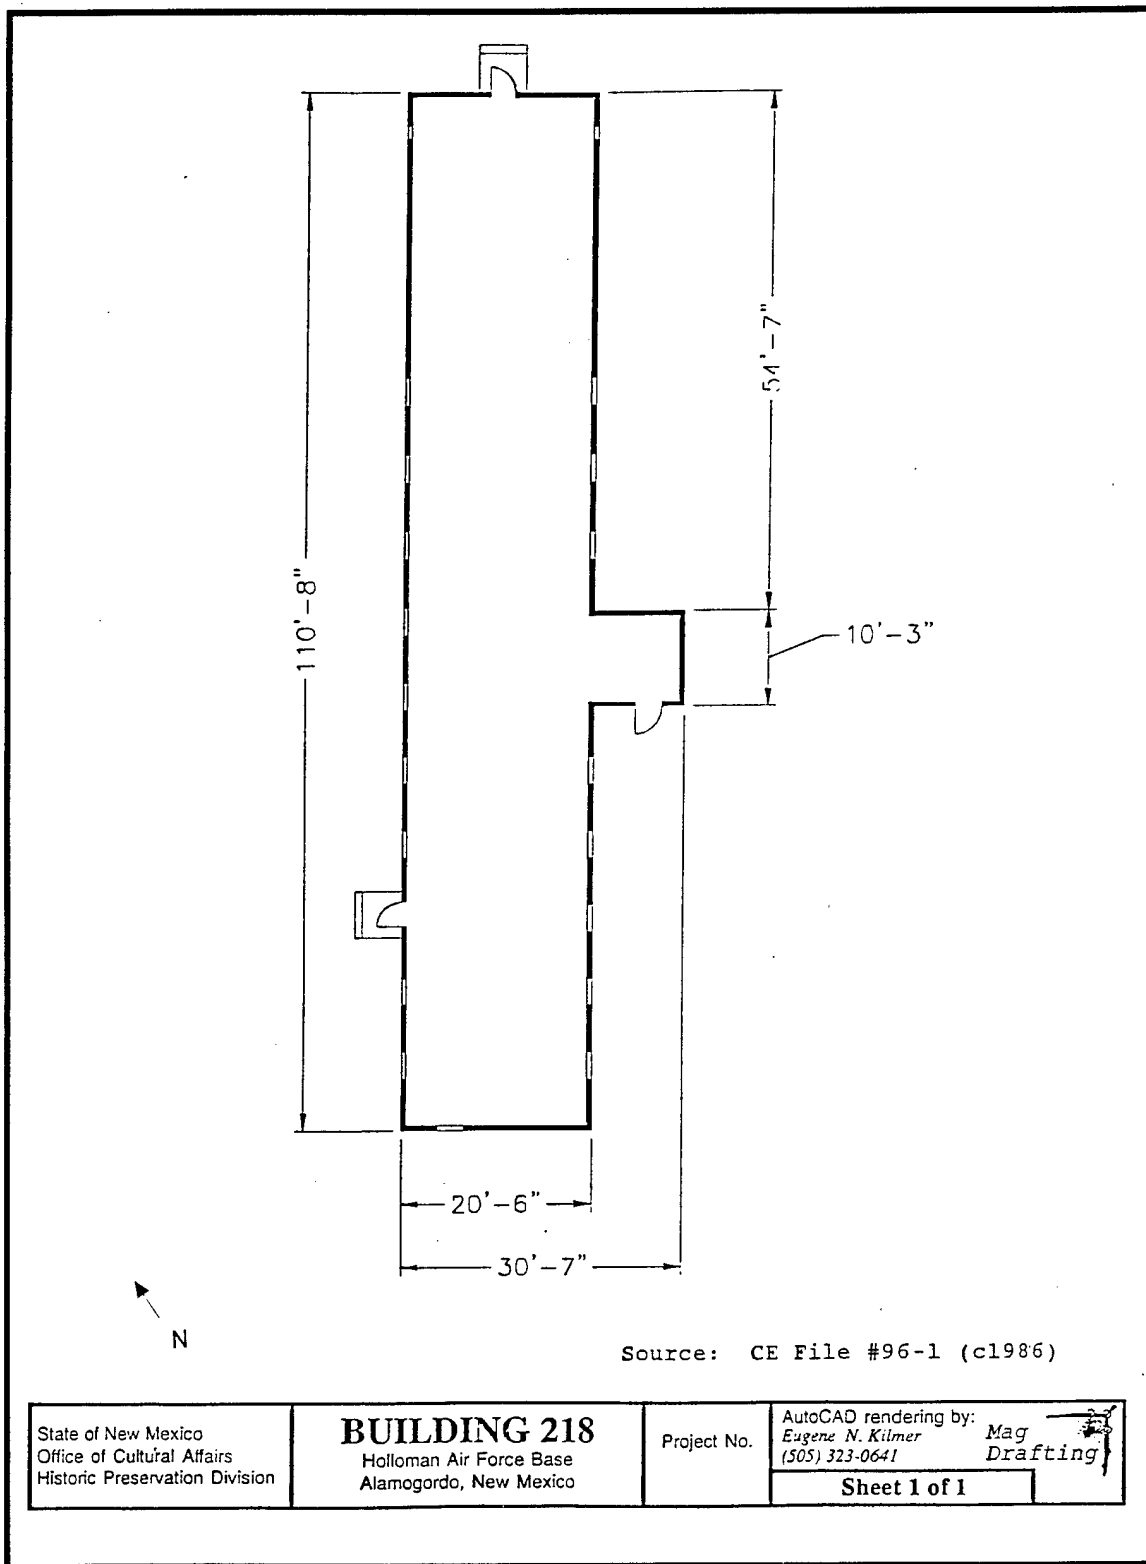
Figure 15. Building 218 floor plan, probably as an Air Force Headquarters Group or Administrative office, ca. 1986.

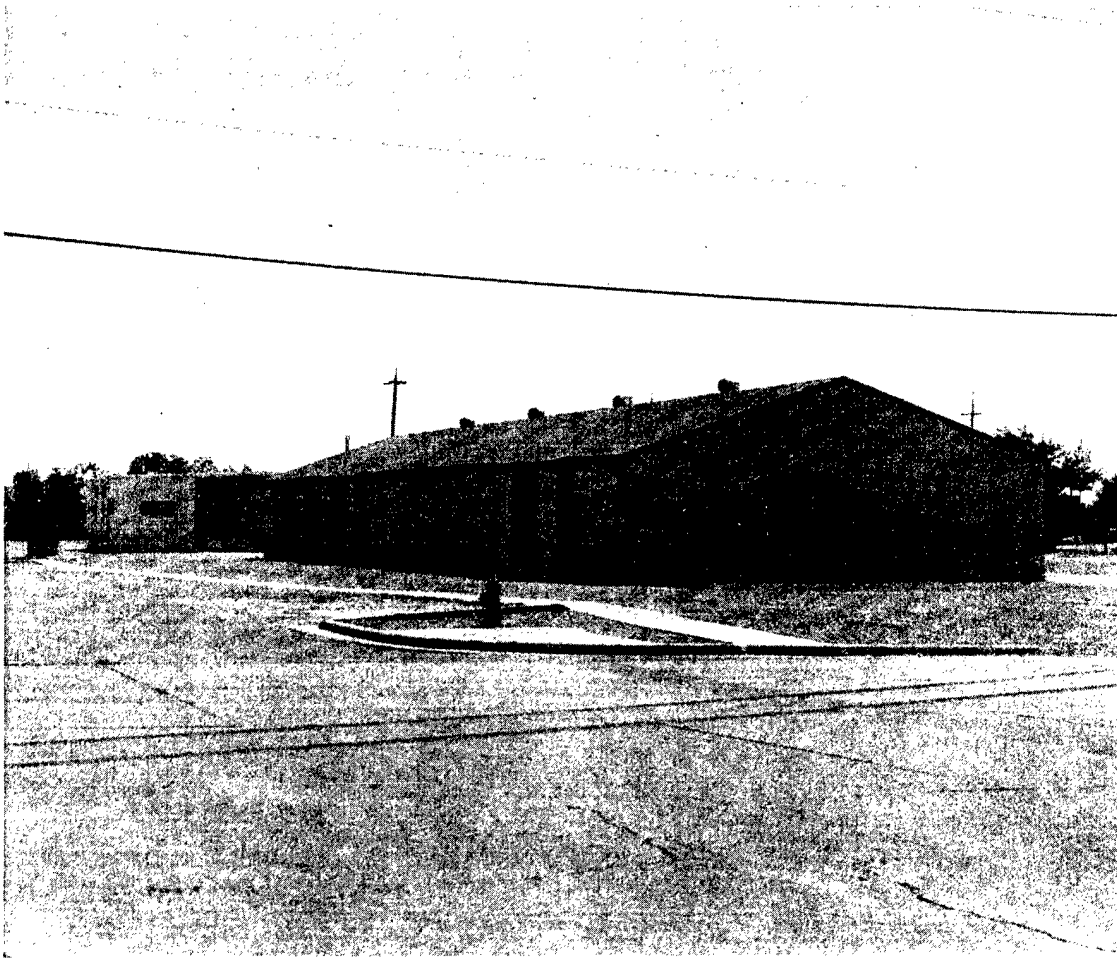
Figure 18. Building 96 as the Housing Supply and Storage facility in 1996, northwest and northeast elevations.

Building 96 retains its original rectangular footprint, single story scope, and gable roof profile, although most of the original architectural features and finishes have been replaced, removed, or obscured. Between 1951 and 1991, at least two extensive renovations occurred at the interior and exterior. The 19 six-light windows have been removed from the southwest and northeast elevations and wood equipment doors have been replaced with roll-up metal doors. An exterior insulation and finish siding system (stucco) replaced

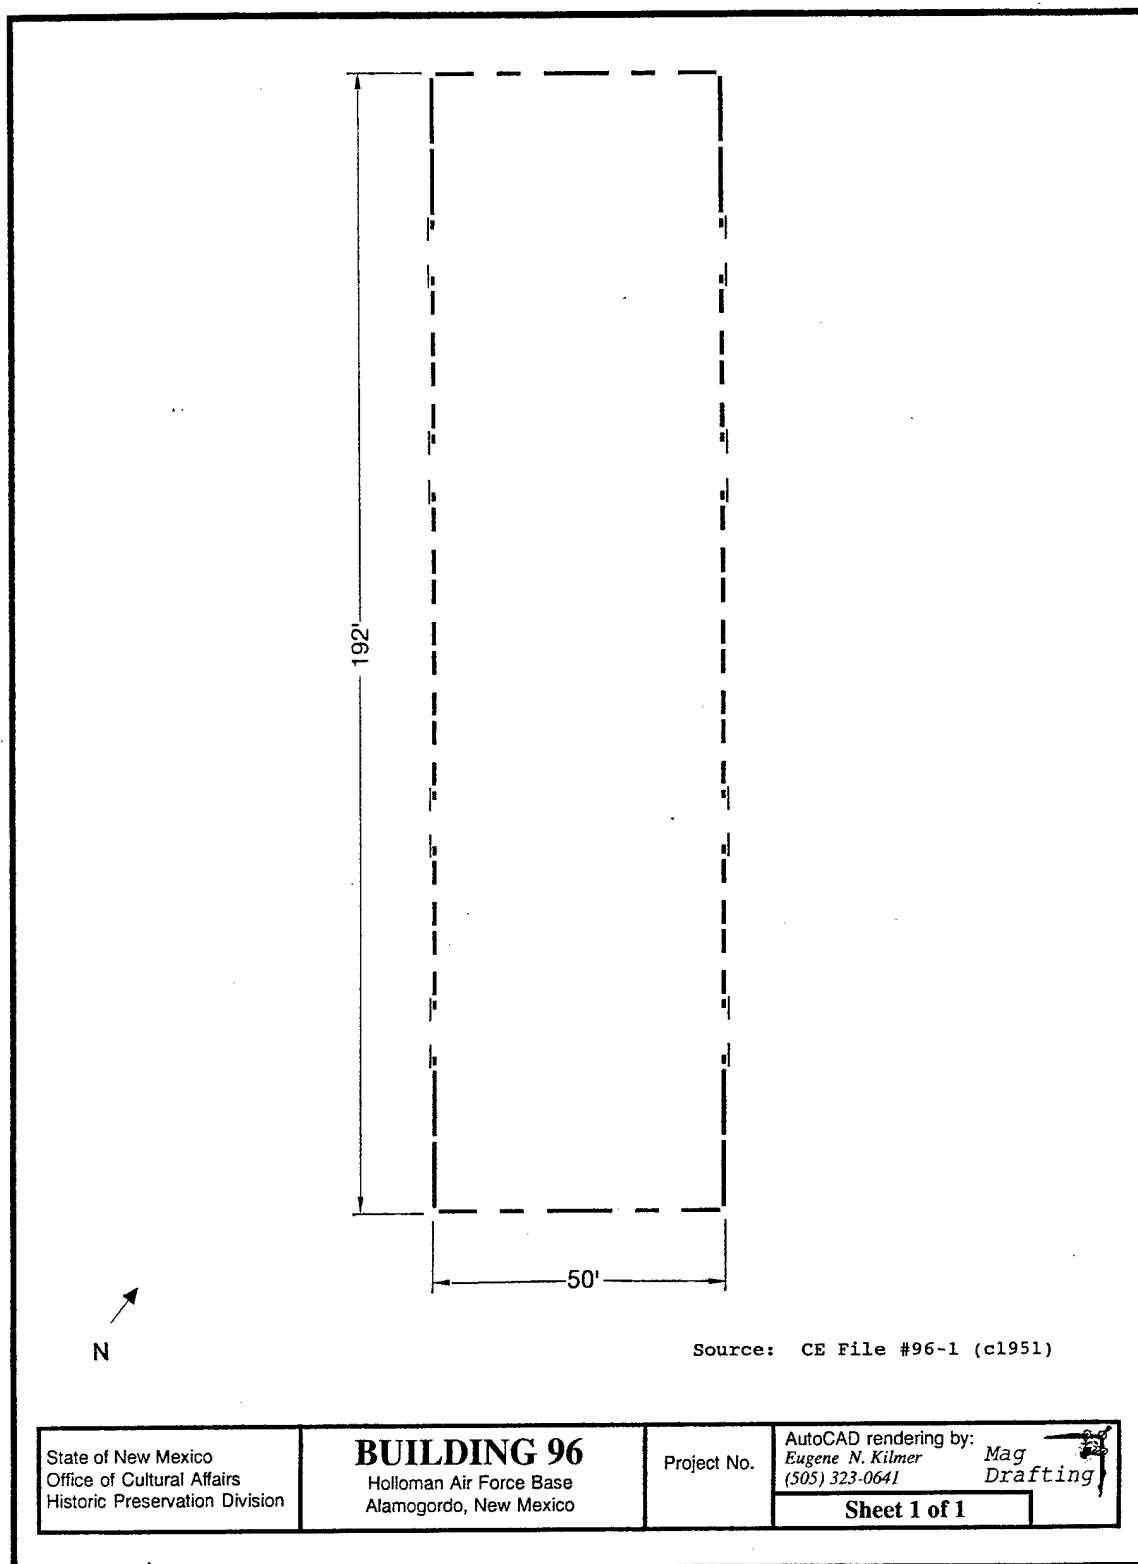
Figure 19. Building 96, floor plan as a Base Warehouse, ca. 1951.

The earliest drawing (1951) shows the 50' x 192' building with an unpartitioned interior (Figure 19). It had four double equipment doors and at least eight windows on both the northeast and southwest elevations,

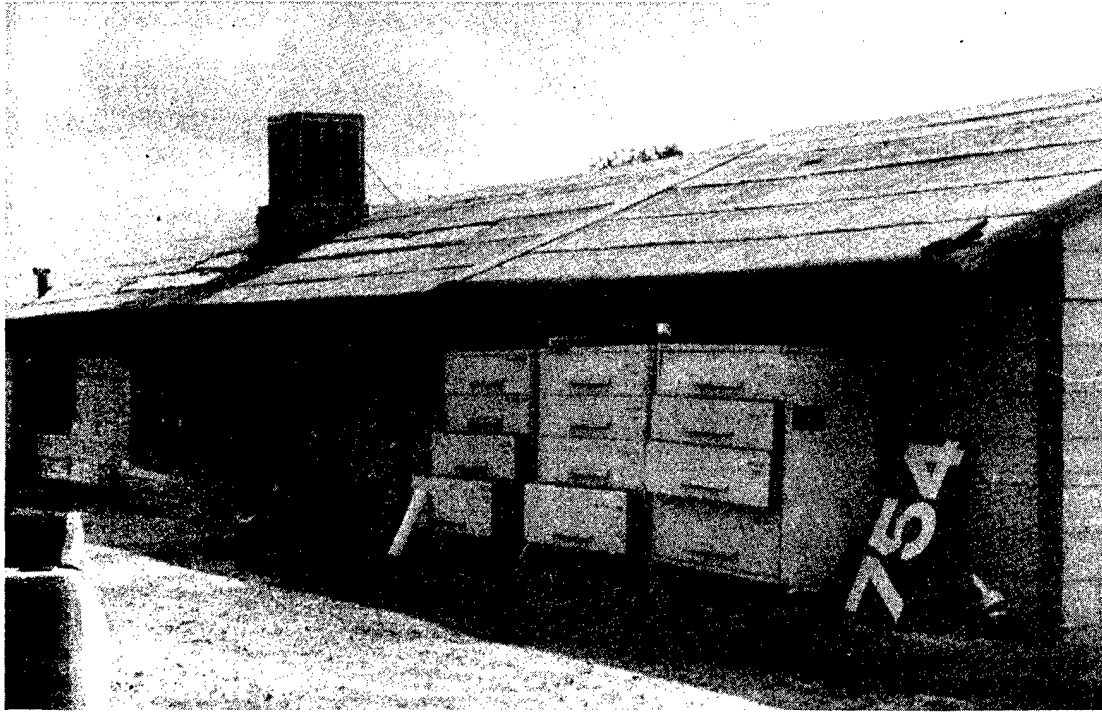
Figure 20. Building 754 as a Golf Course storage facility in 1996 prior to demolition, north and east elevations.

At the time of the assessment, Building 754 maintained its original rectangular footprint, single story scope, and gable roof profile, although it no longer retained historic integrity due to extensive alterations

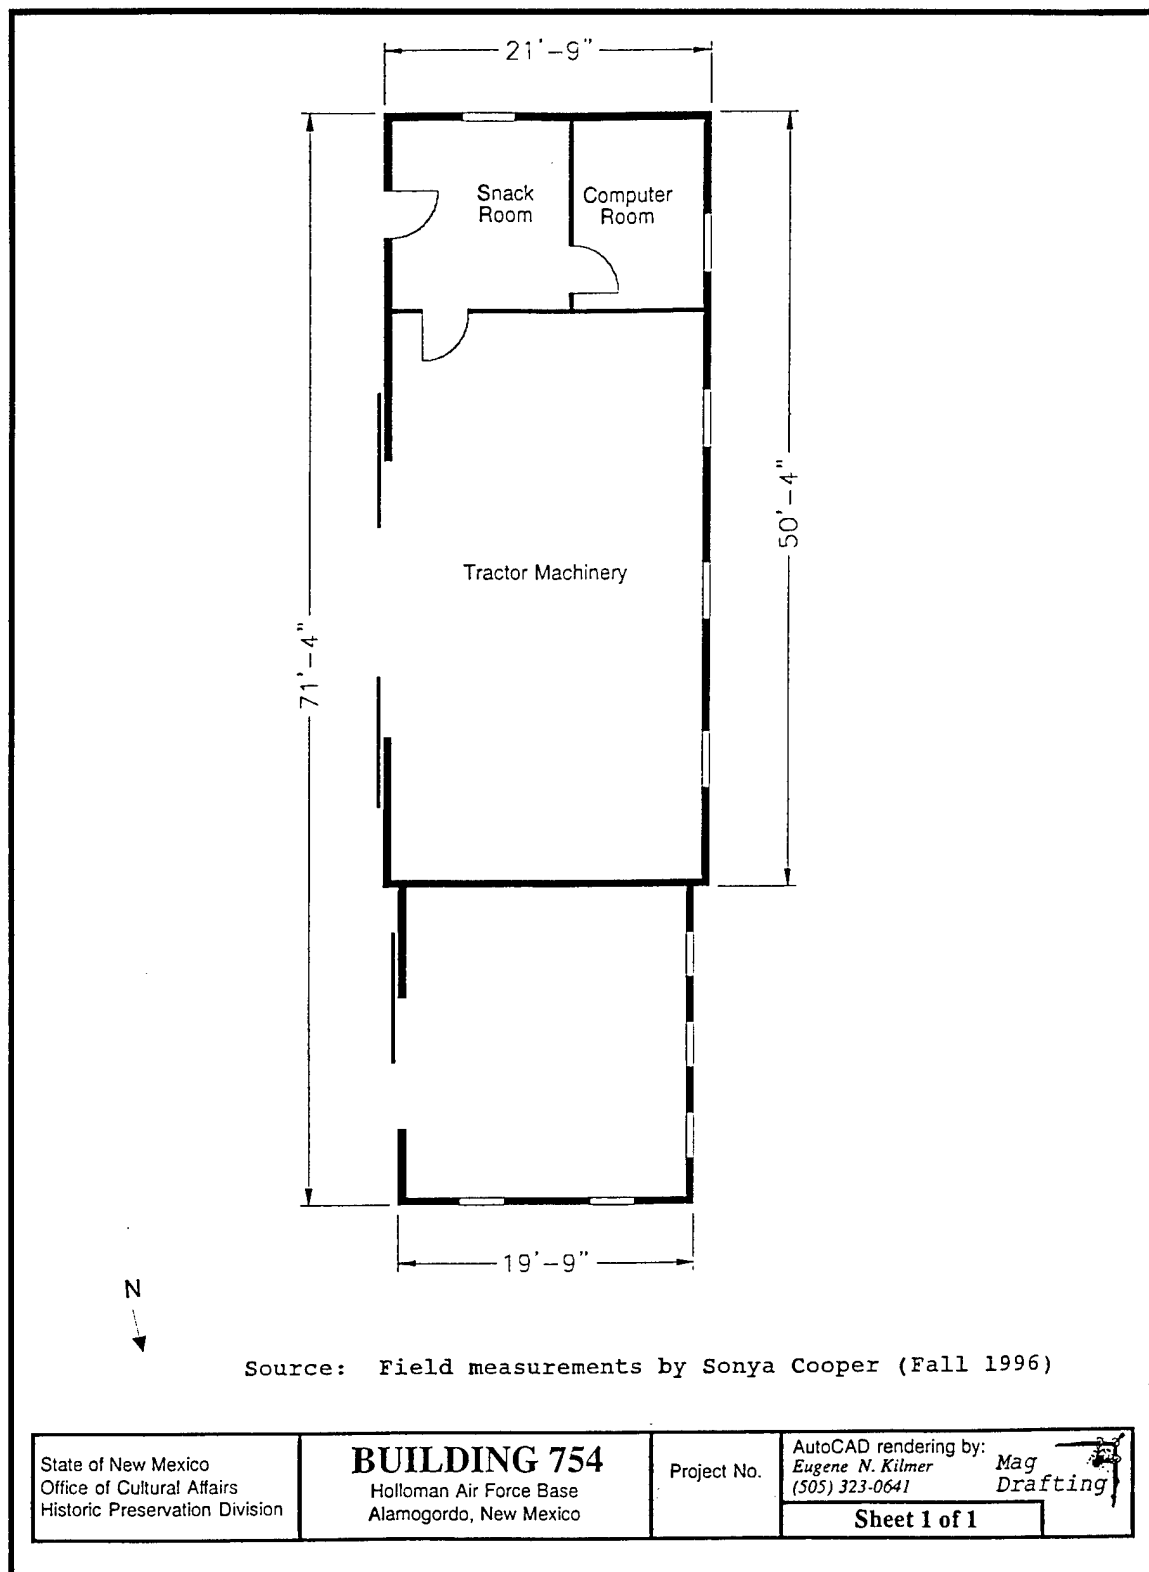
Figure 21. Building 754, floor plan of Golf Course storage building in 1996.

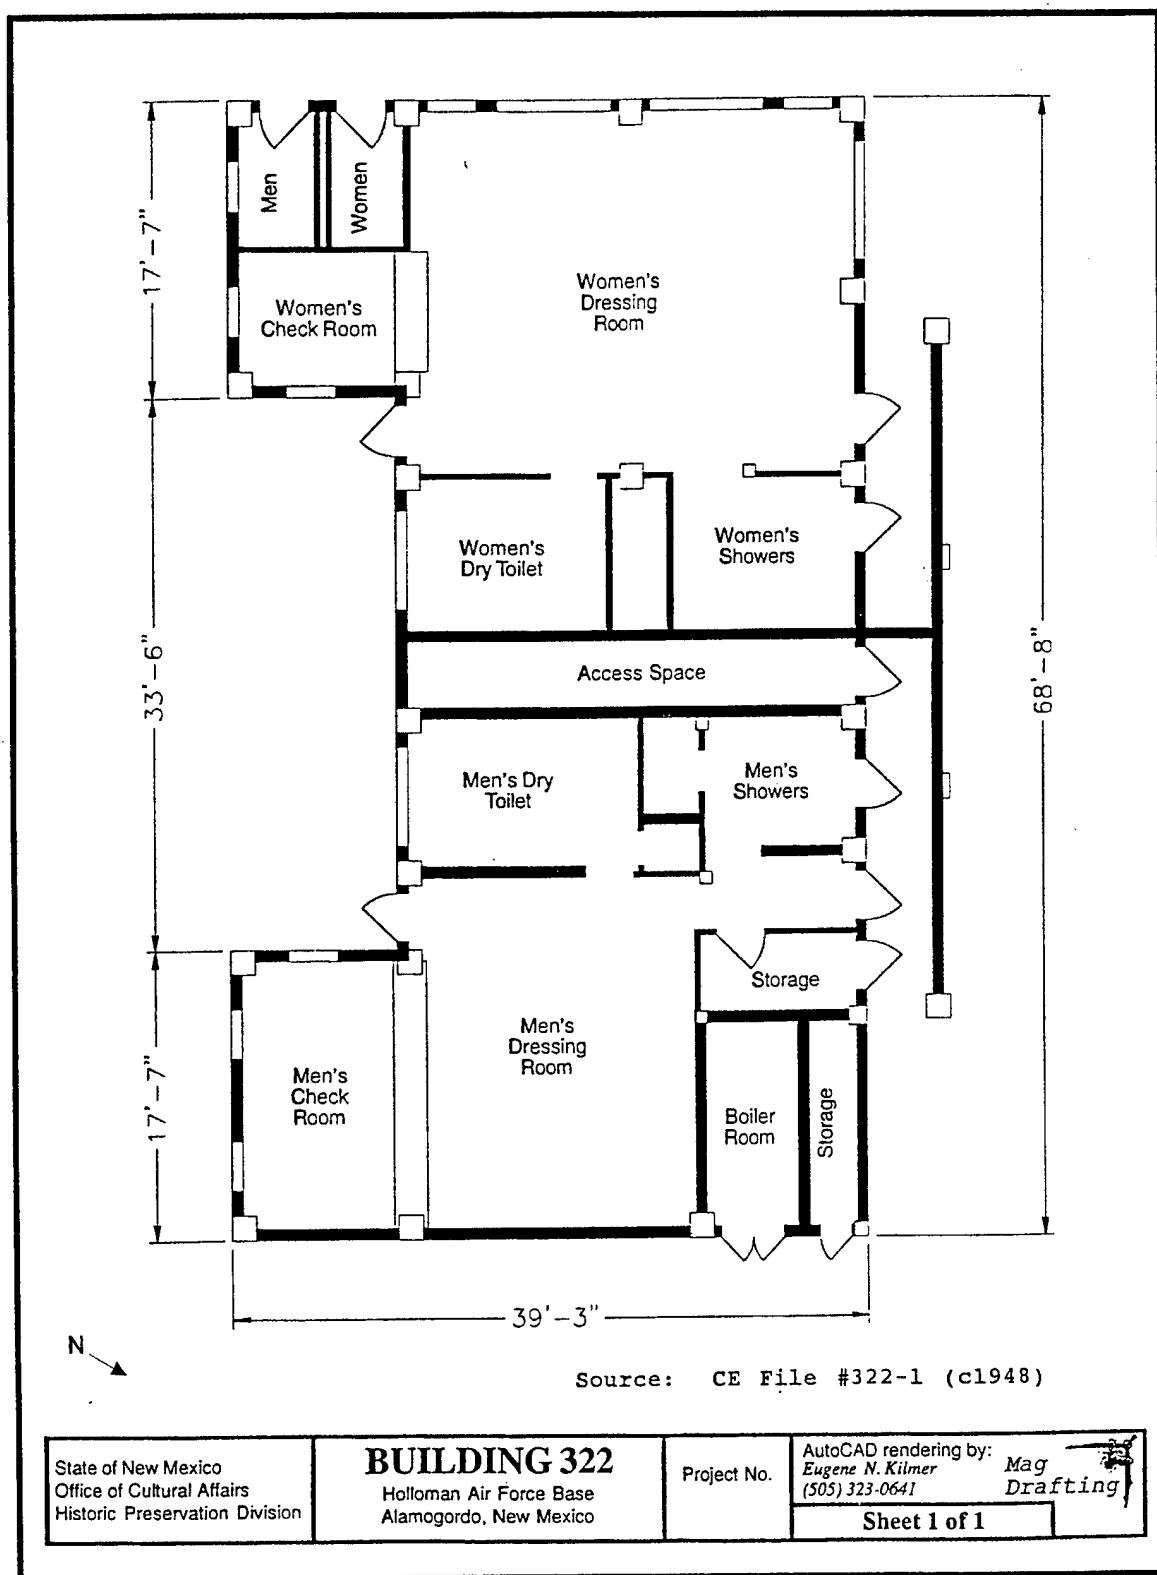
Figure 23. Building 322, floor plan of Swimmer's Bathhouse, ca. 1948.

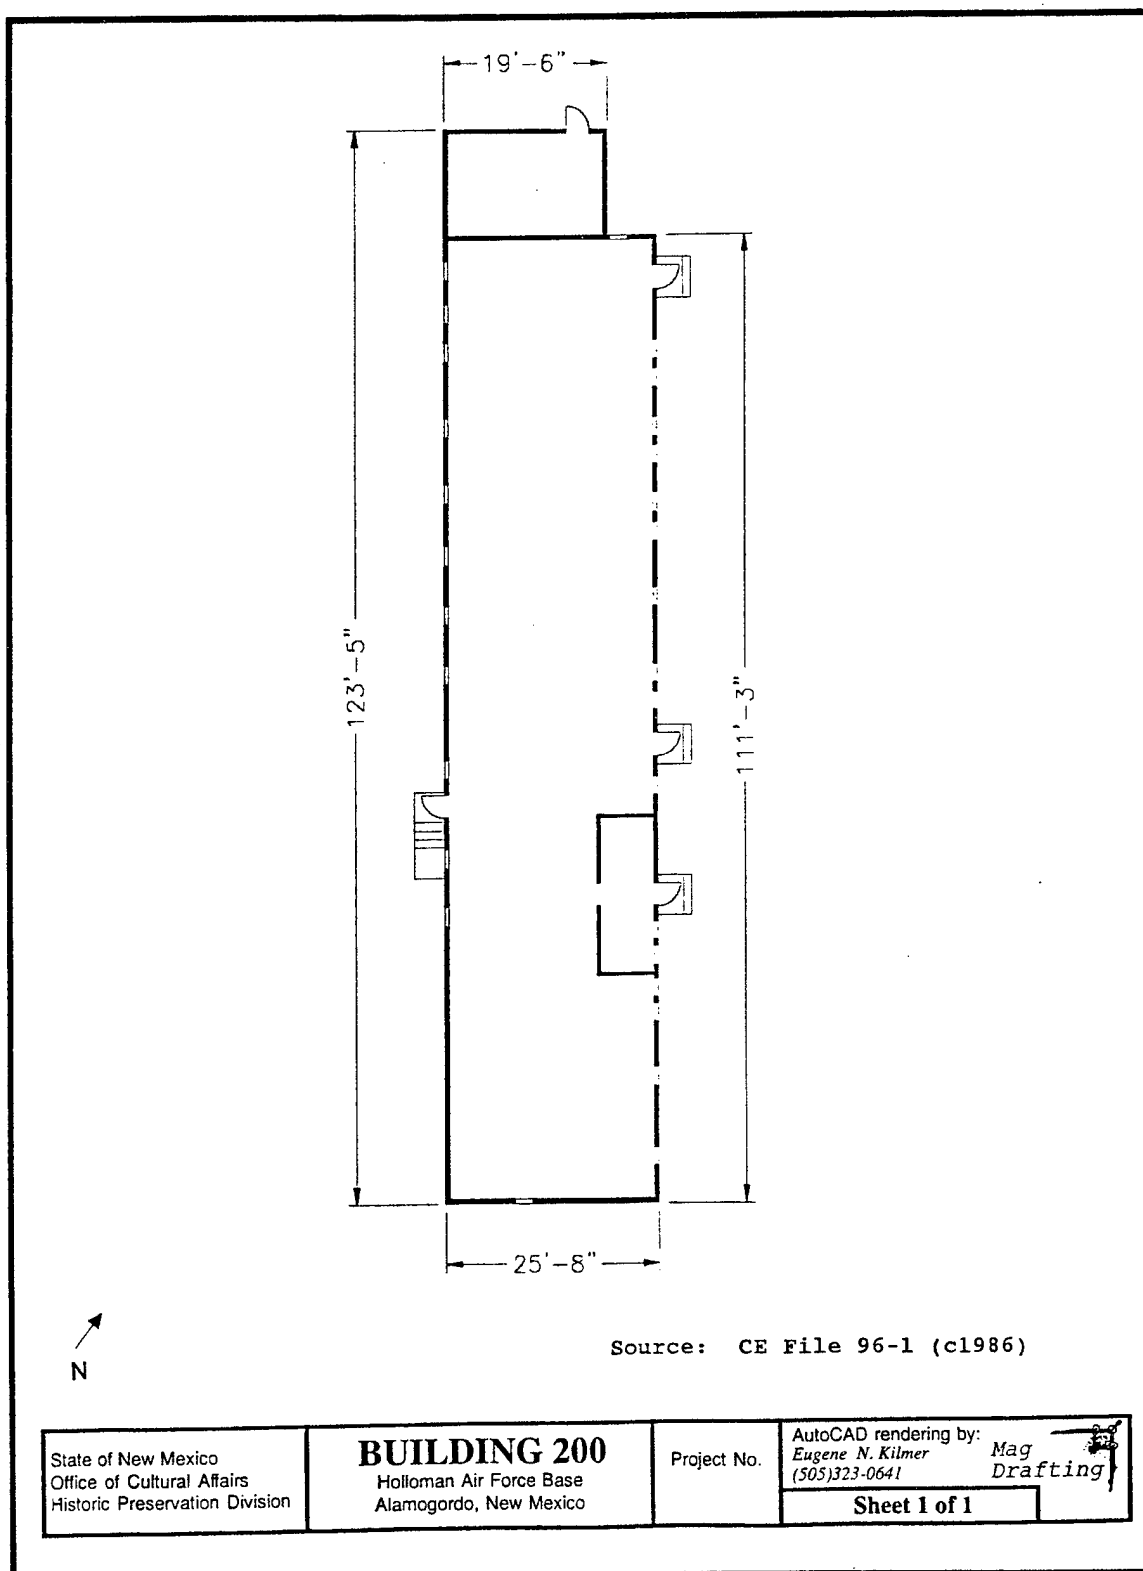
Figure 25. Building 200, floor plan as Service Outlet Exchange or Thrift Shop, ca. 1986.

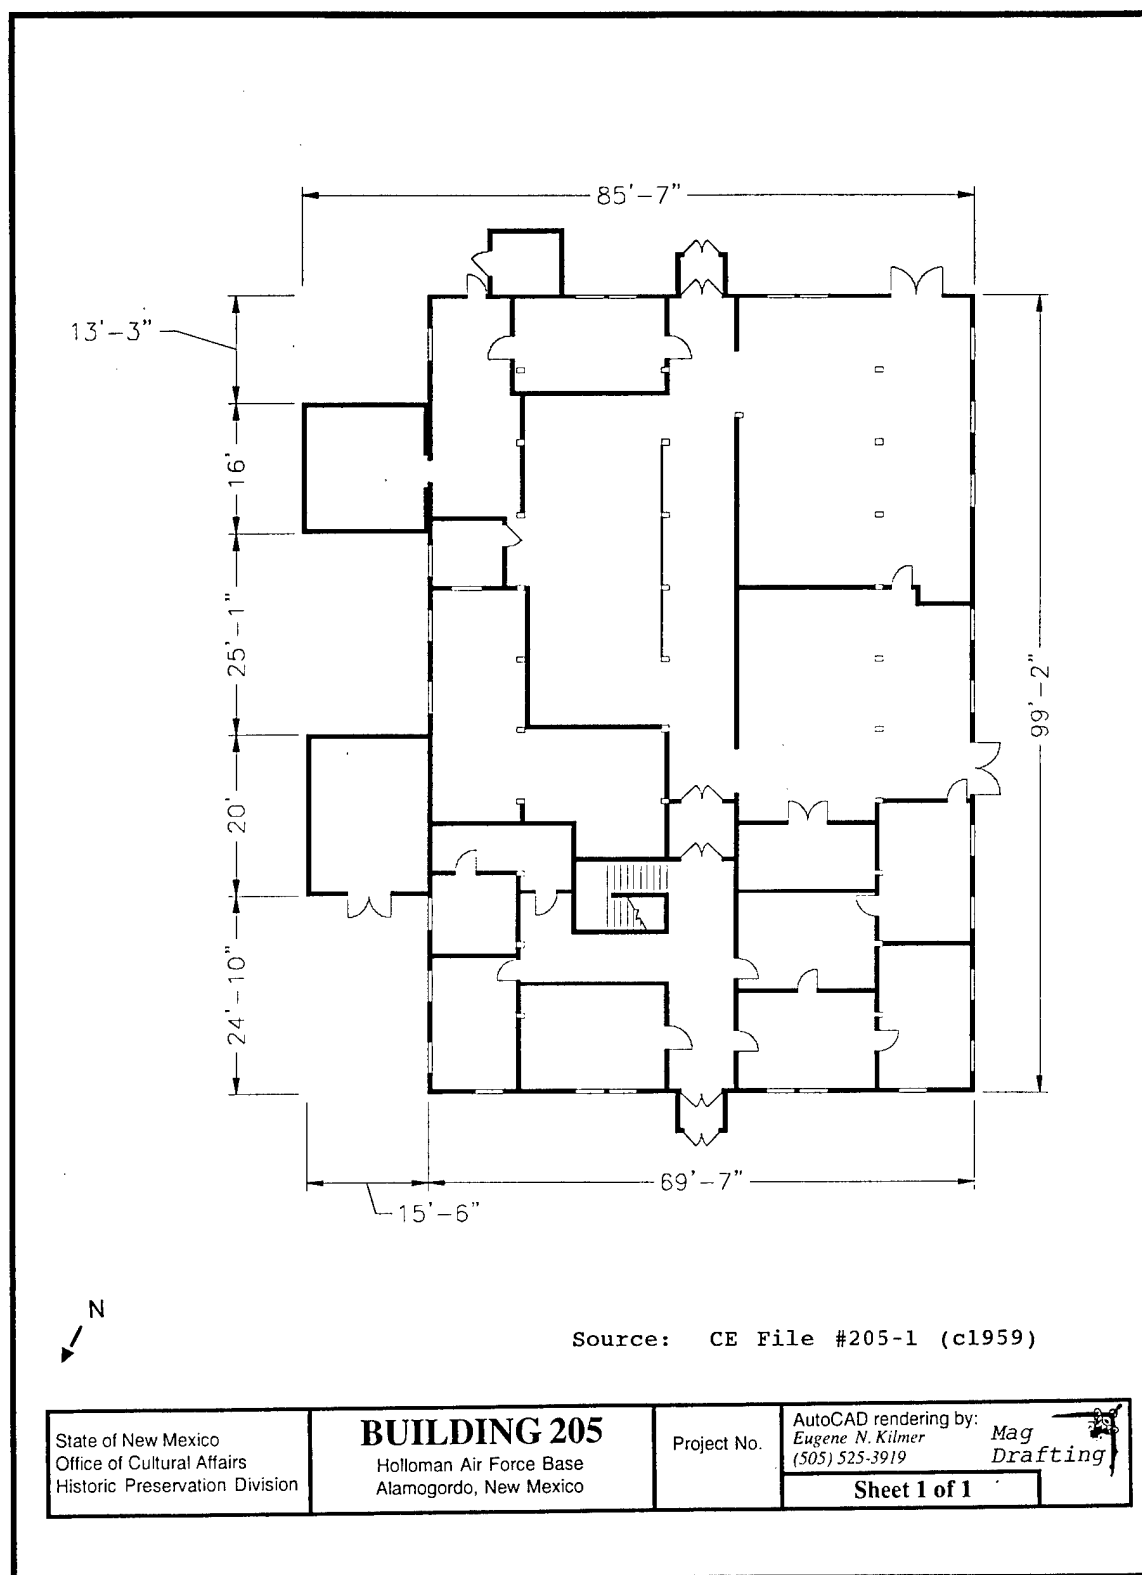
Figure 27. Building 205, floor plan as a possible Administrative Office, Headquarters Division, ca. 1959.

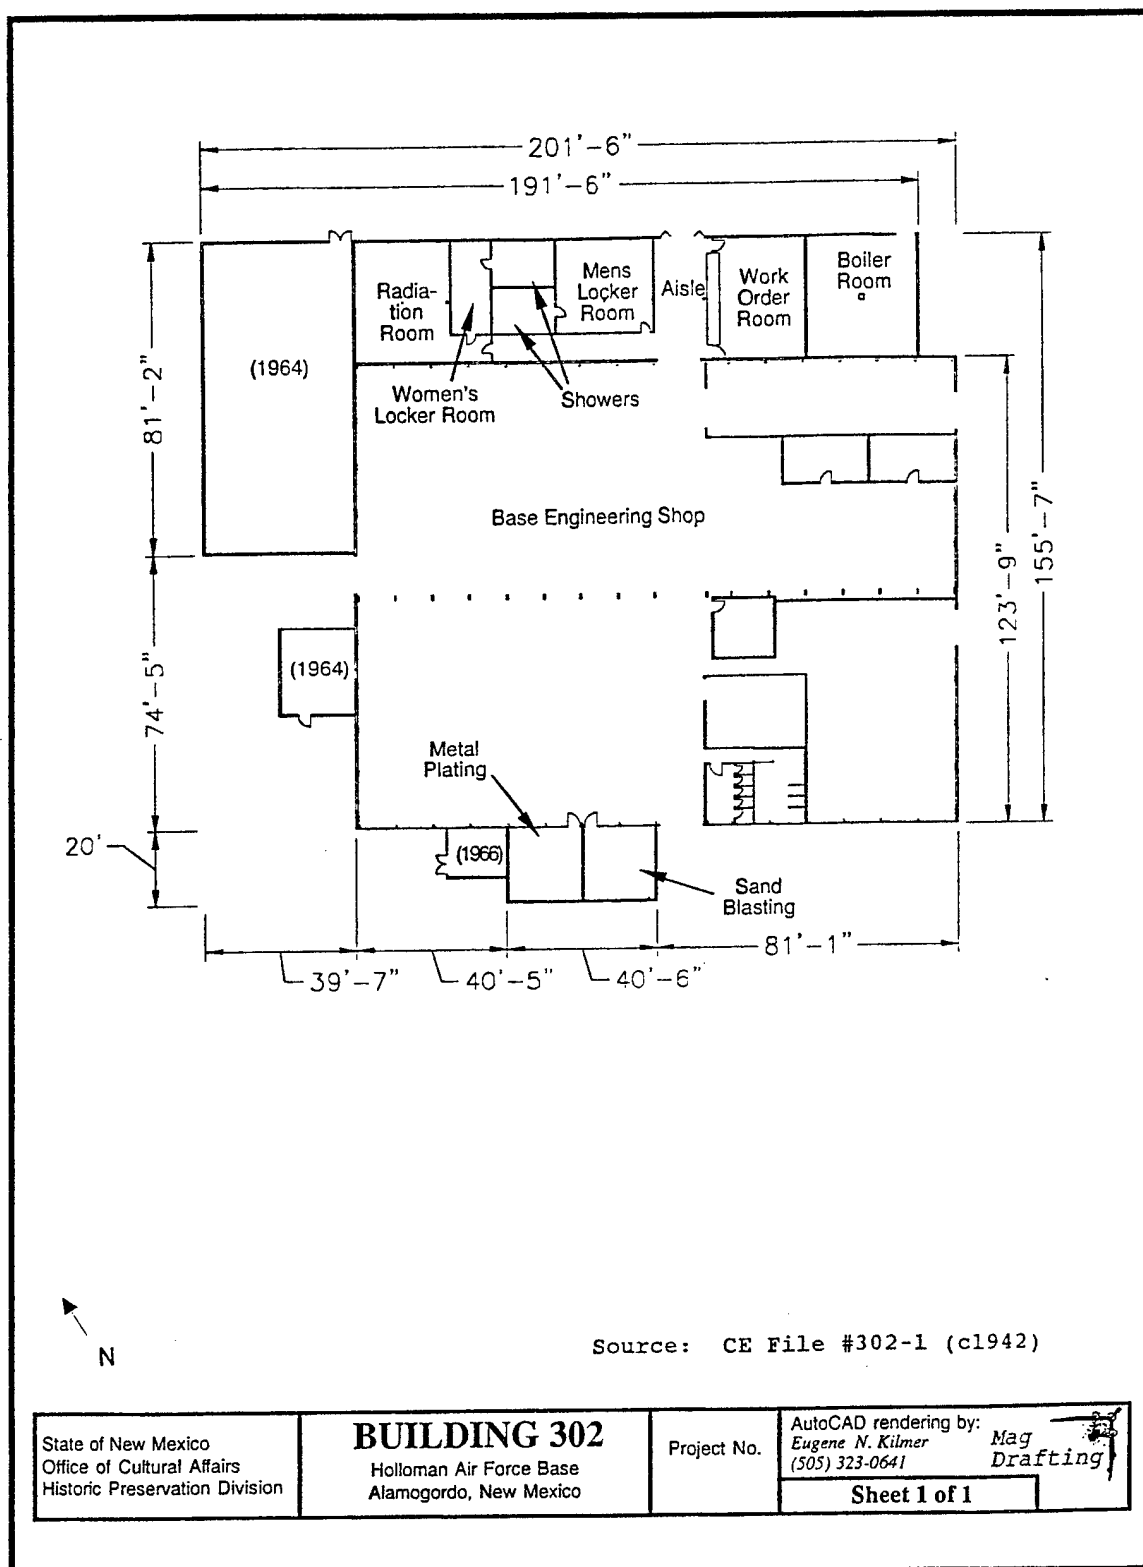
Figure 29. Building 302, floor plan as the Base Engineering Shop, ca. 1942.

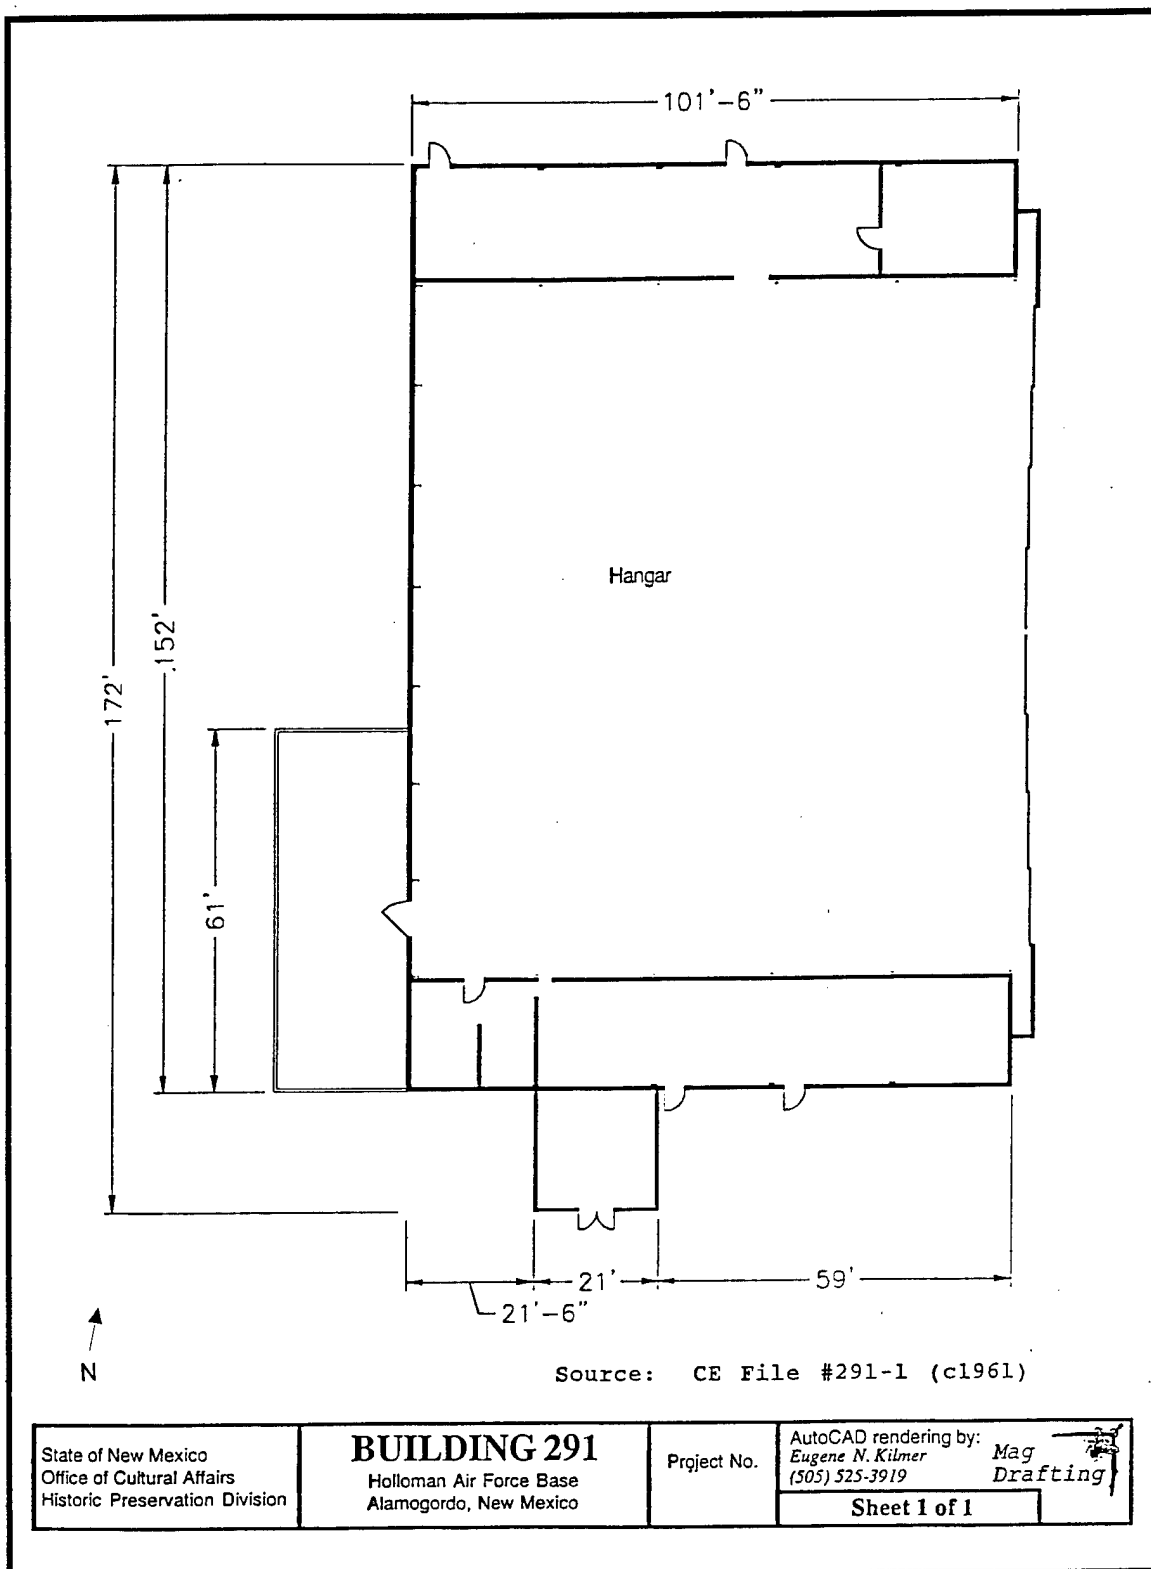
Figure 33. Building 291, floor plan as a probable Maintenance Dock for Small Aircraft, ca. 1961.

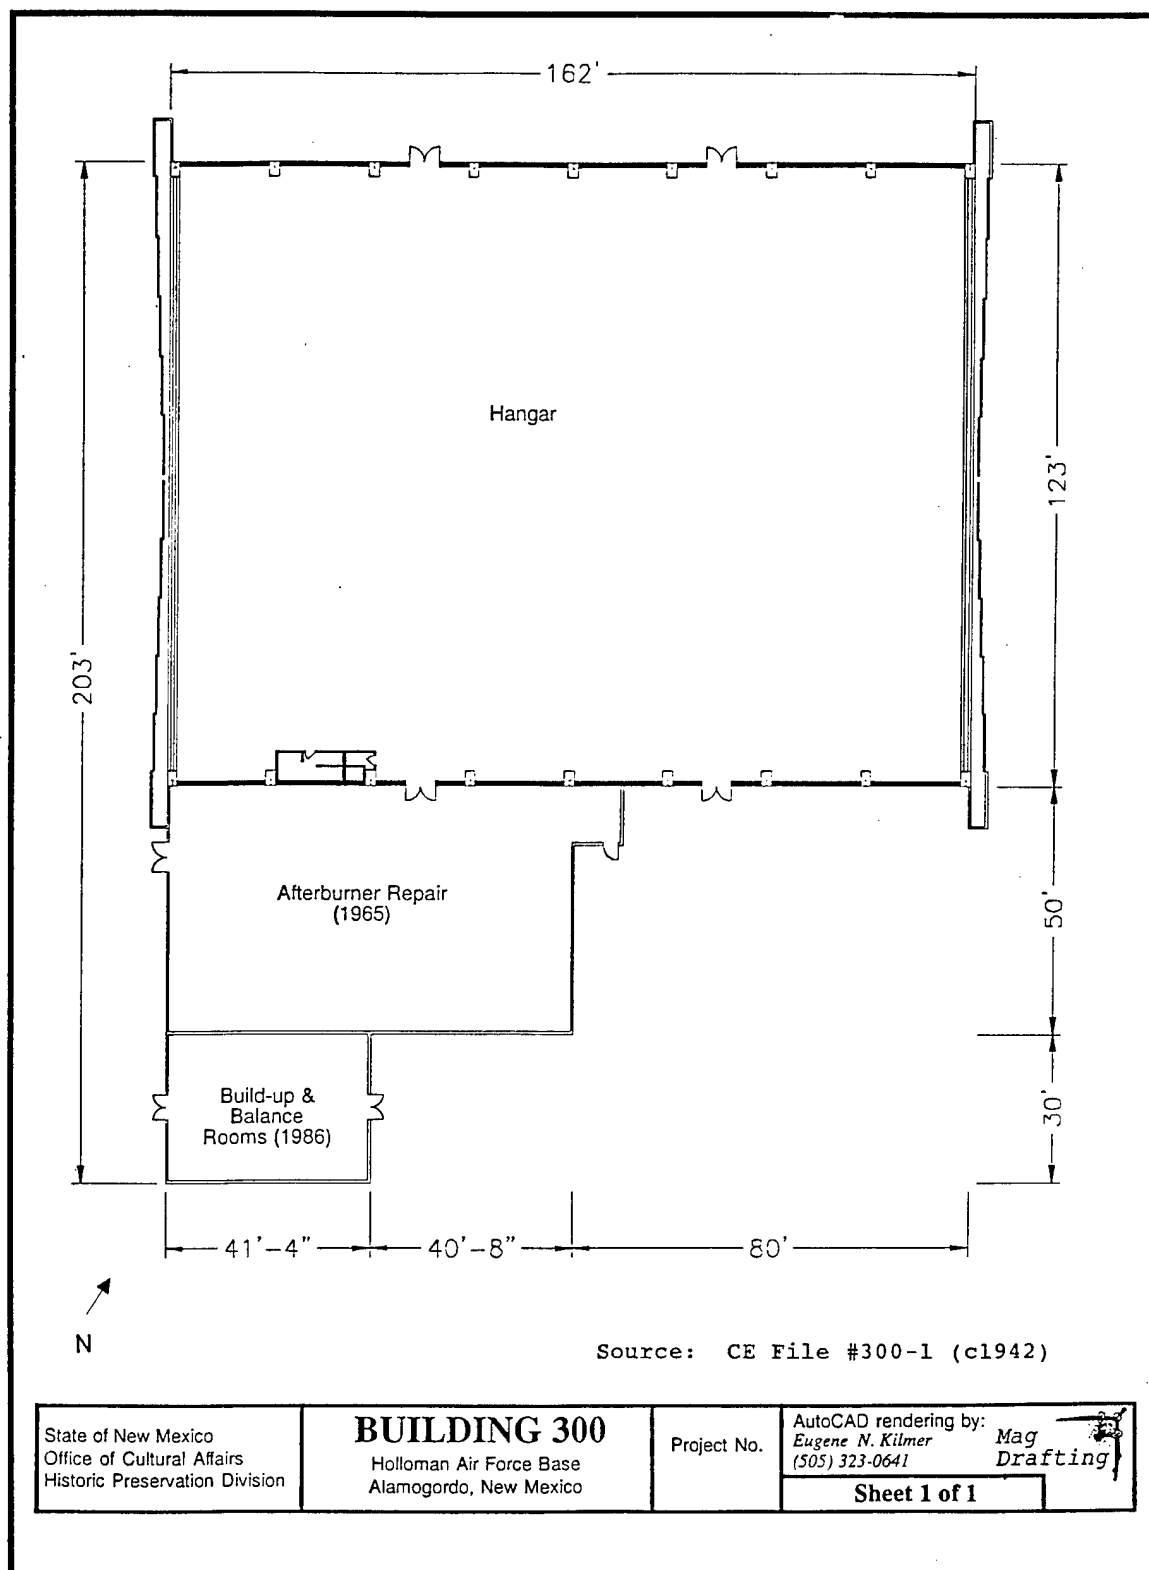
Figure 35. Building 300, floor plan of Field Maintenance Hangar, ca. 1942.

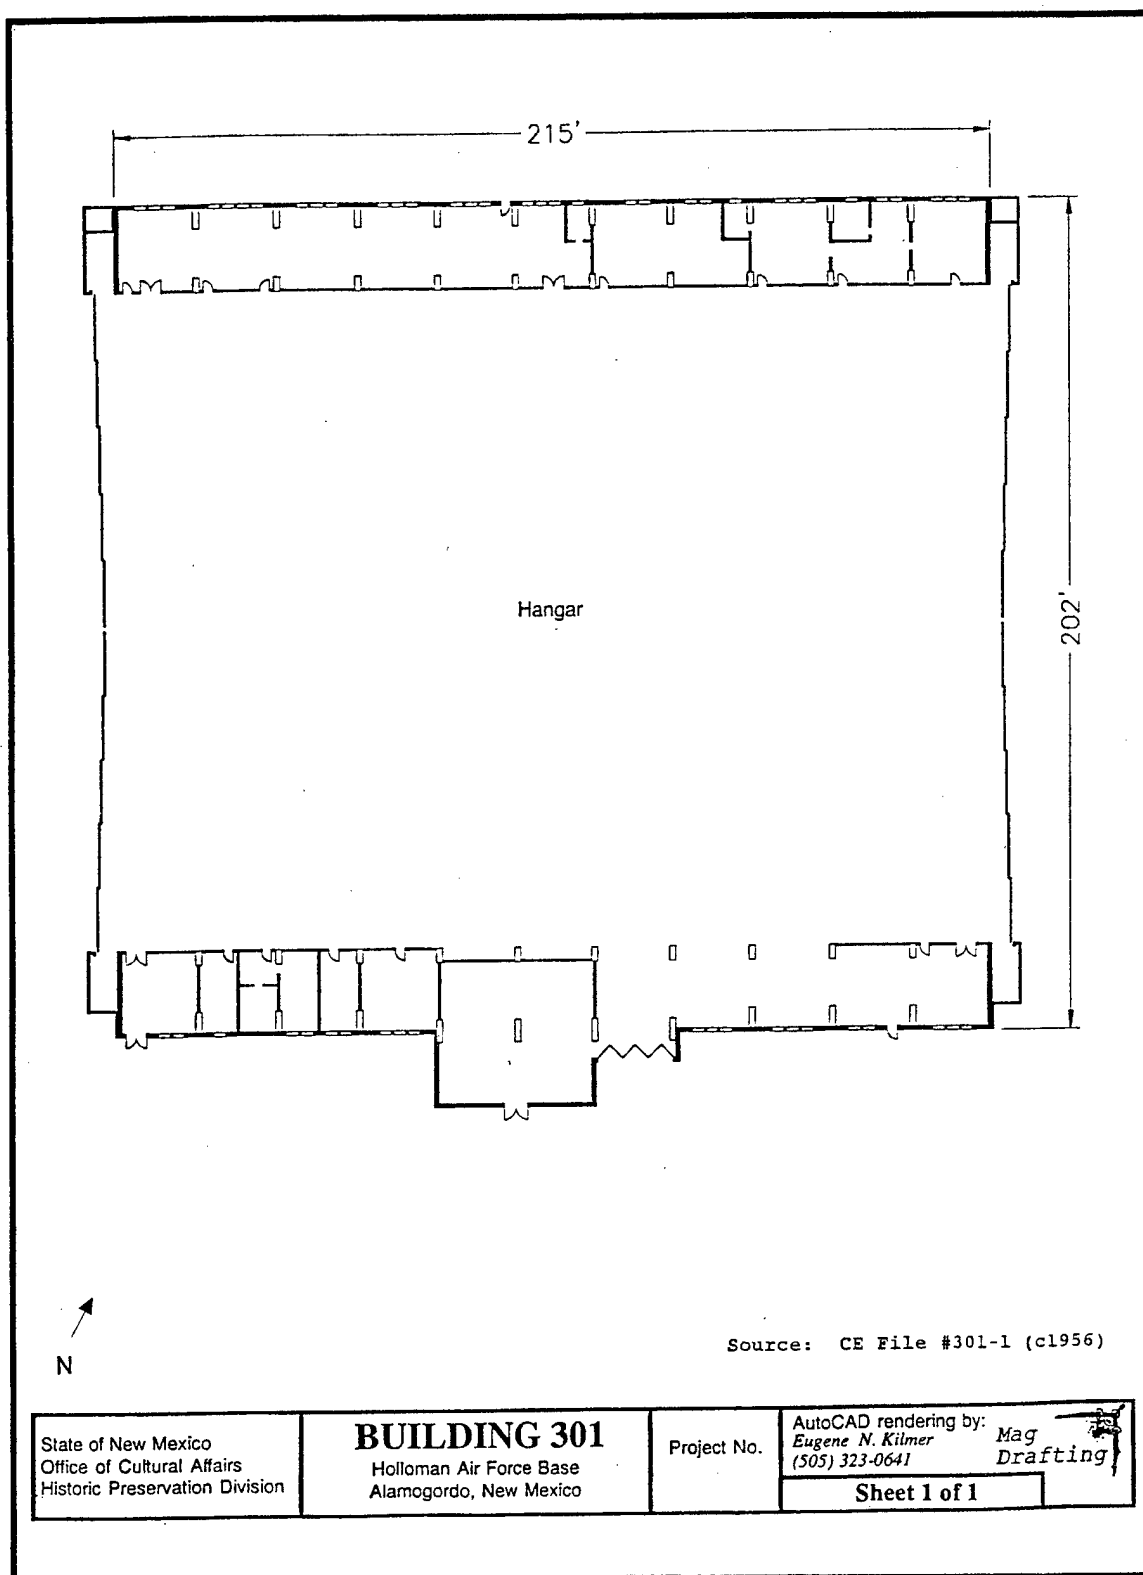
Figure 37. Building 301, floor plan as a probable Field Maintenance Hangar, ca. 1956.

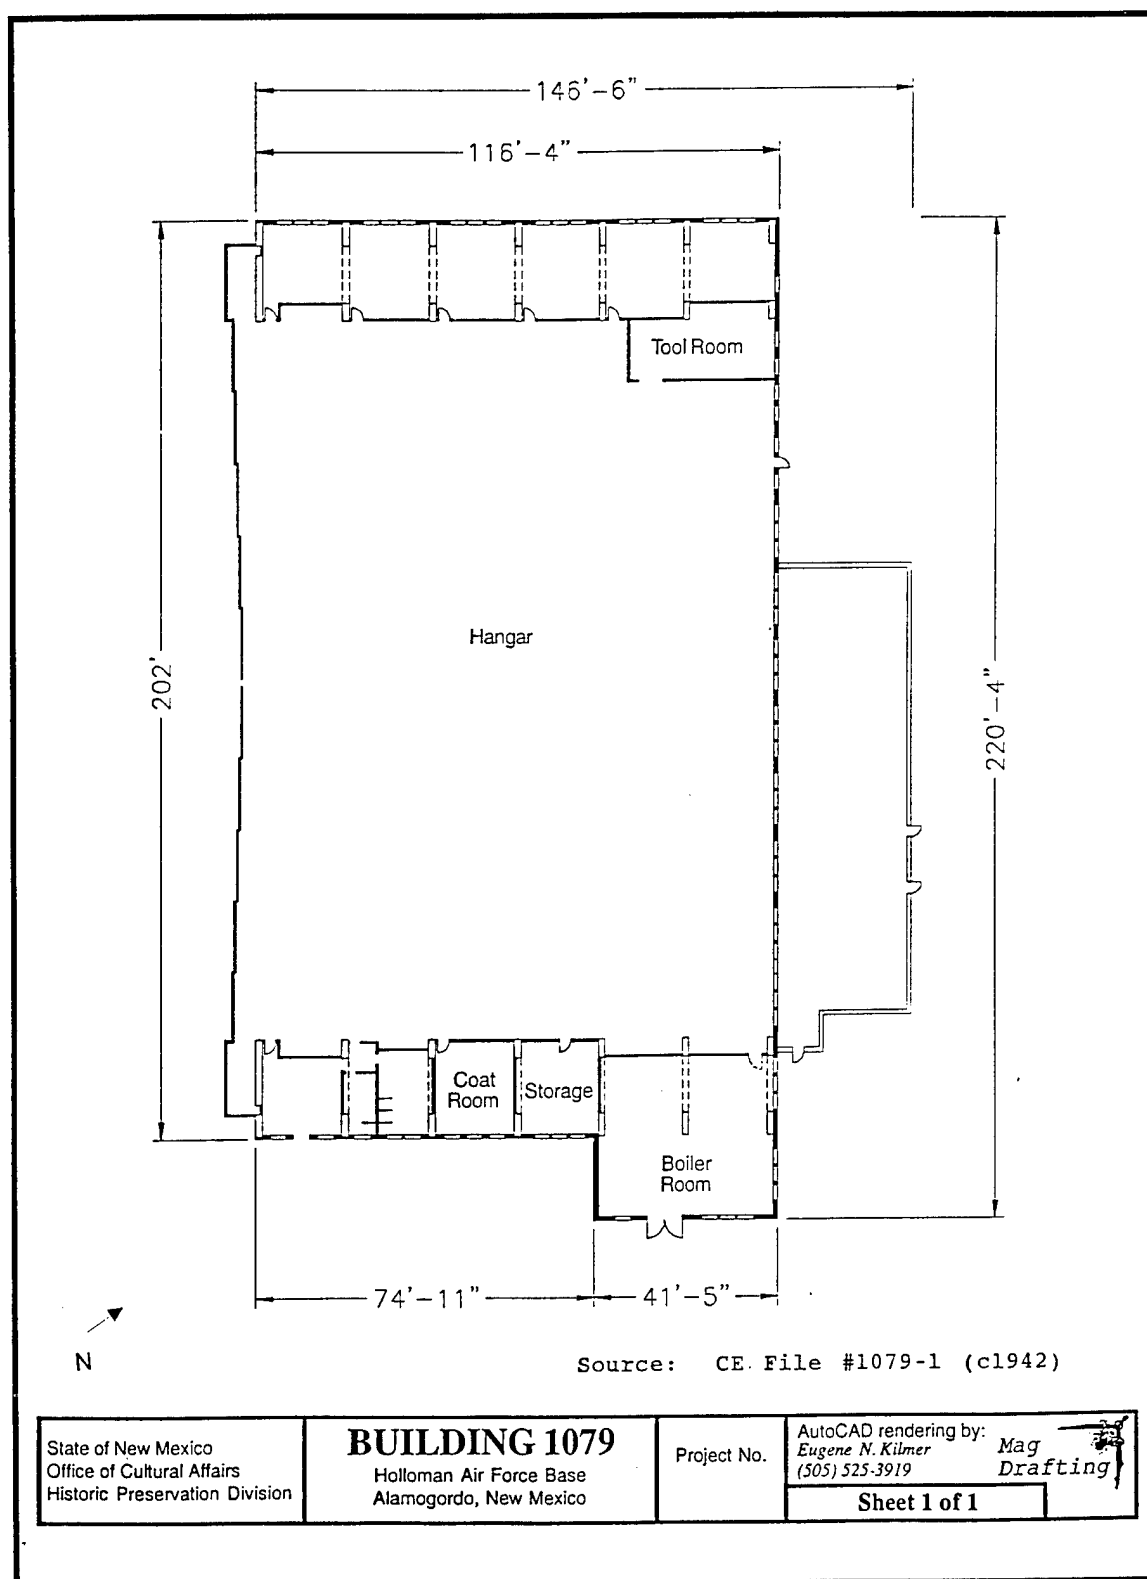
Figure 39. Building 1079, floor plan as a Field Maintenance Hangar, ca. 1942.
